Manhole Inspection Summary

Manhole # S51K__023MH

Insp Date: **3/31/08 2:18 PM**

Location Address: **unknown alley**

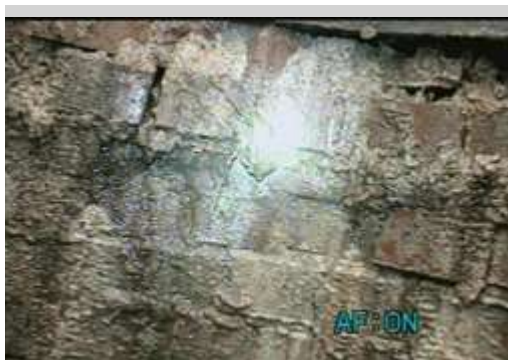
Defect 6

Condition: ☐ Sound ☒ **Cracked** ☐ Root Intrusion ☐ Loose Brick ☒ **Deteriorated**

Infiltration: ☐ None ☐ Joint ☒ **Cracks** ☒ **Mortar** ☐ Roots ☐ Wall

other side of frame adjustment

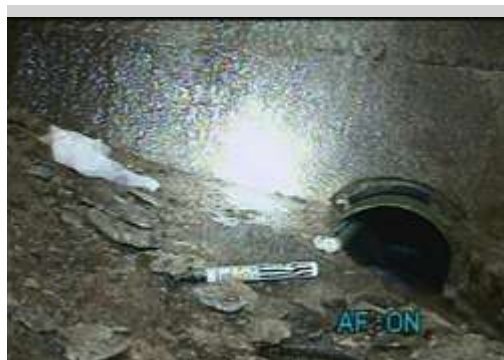
Defect 5

Condition: ☐ Sound ☐ Cracked ☐ Root Intrusion ☒ **Deteriorated** ☐ Leaks ☐ Debris

bench debris

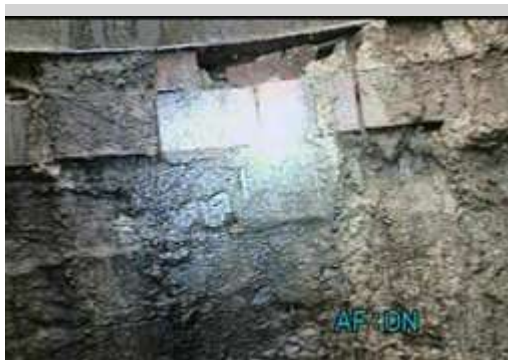
Defect 4

holes in frame adjustment have infiltration

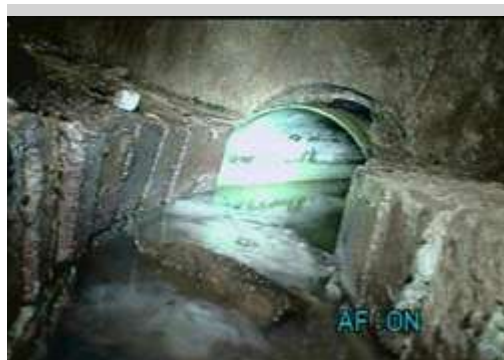
Defect 3

Condition: ☐ Sound ☐ Cracked ☐ Root Intrusion ☐ Deteriorated ☐ Leaks ☒ **Debris**

channel debris

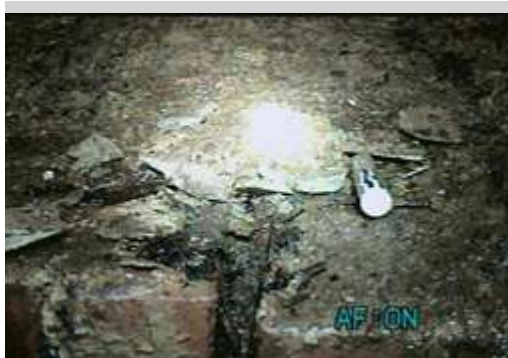
Defect 2

bench missing brick

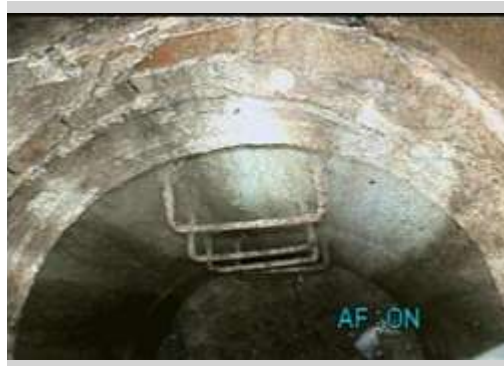
Defect 1

Steps Count: **4** Missing: **0** ☒ **Corroded**

steps
